Location:
Granary at Crowmarsh Battle Farm
Preston Crowmarsh, Oxfordshire

Client:
Crowmarsh Battle Farms Ltd

HISTORIC STUDY

Repair and refurbishment of derelict granary and conversion to farm office

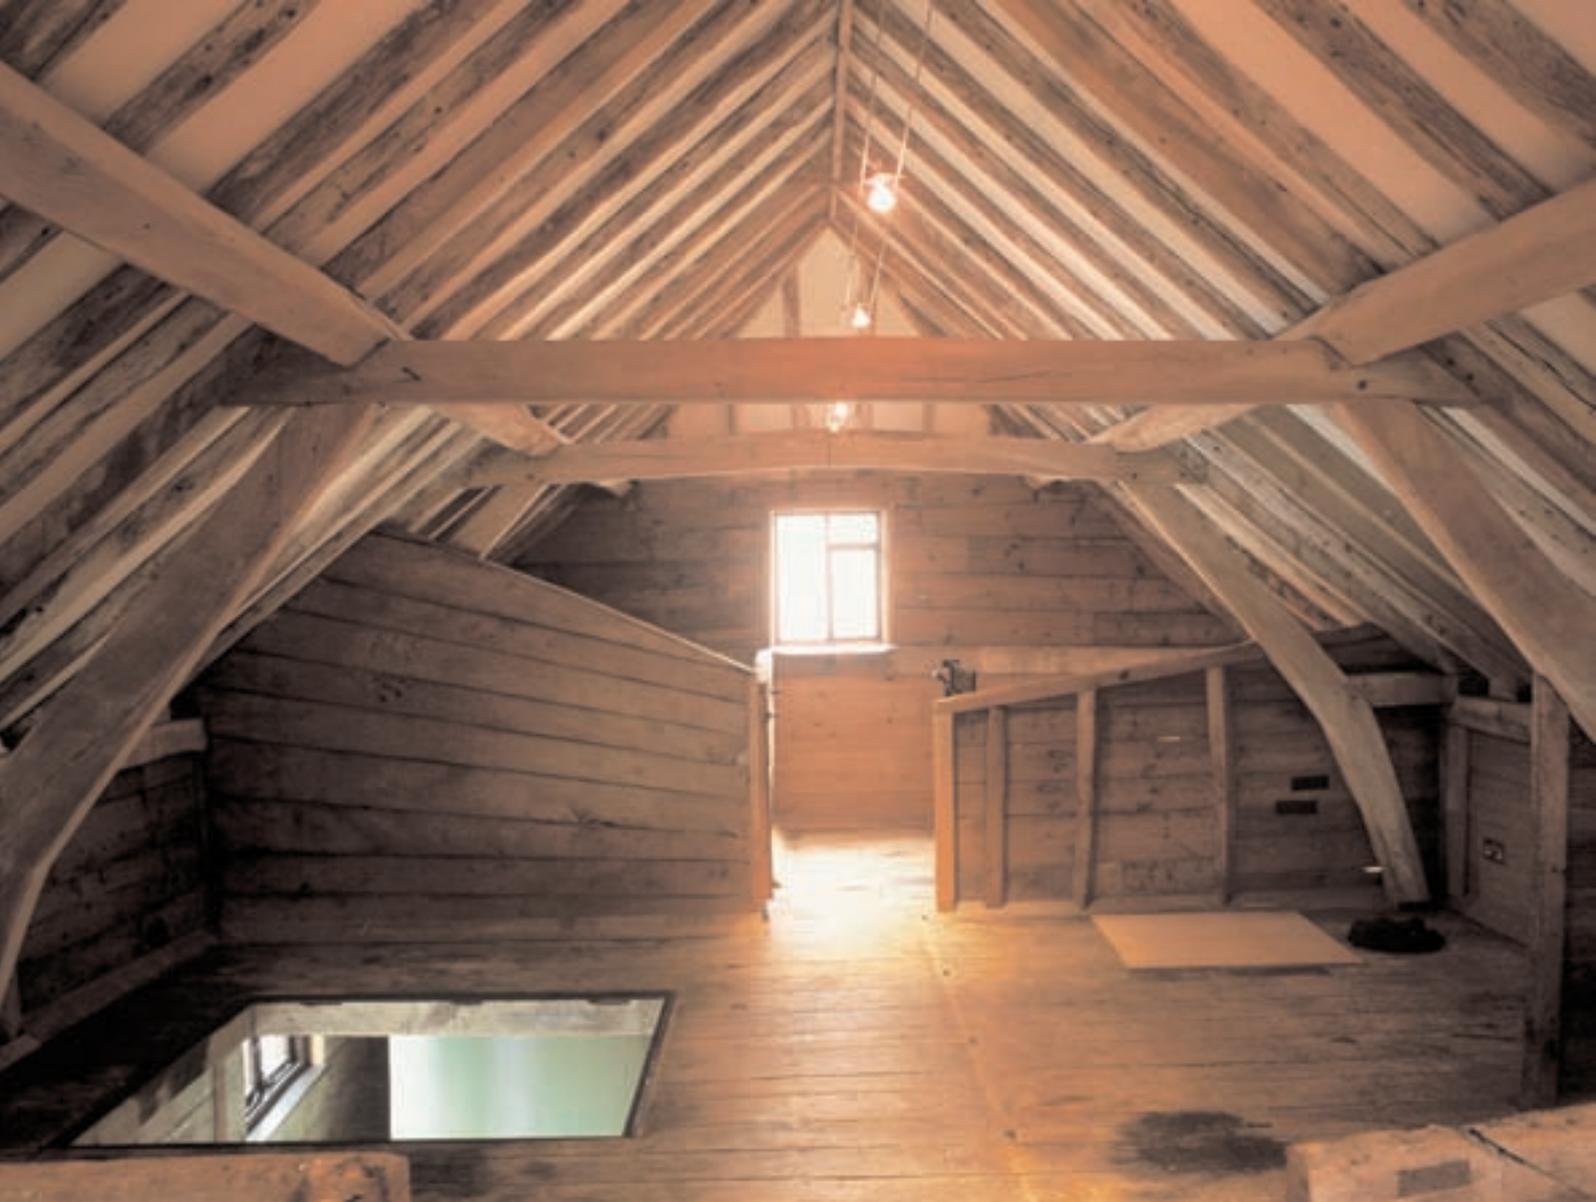
Right The refurbished granary structure, on repaired staddle stones.

The staddle stones, each comprising a tapered square shaft and separate round 'mushroom' cap to prevent both moisture and vermin ingress to the granary, were re-bedded on the new footings and the granary was once again craned back into its original location for the remainder of the works.

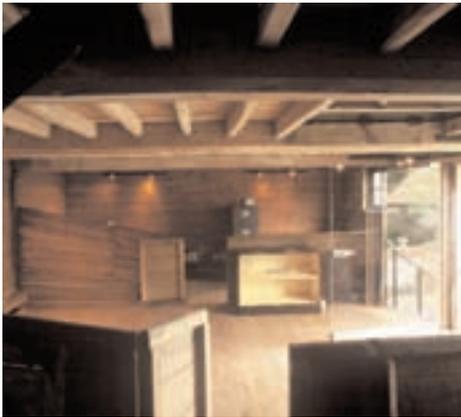
The Grade II listed granary dated 1800 - evidenced by a carved legend on a central post of the existing timber frame - was in a very poor state of repair, with significant subsidence having occurred beneath the fourteen staddle stones on which it stands. The ground subsidence was attributed to the lack of proper footings and any form of

The lower part of the buildings timber frame was in very poor condition too, with the original timbers significantly reduced through rot and insect infestation. Many of the connections had deteriorated completely, which had further contributed to the structure's leaning appearance.

Below Granary before refurbishment.

To enable works to new foundations and below-ground services, the entire building was stabilised with temporary bracing before being lifted by crane onto concrete blockwork supports some 40 feet away.

In its new location, the timber frame was repaired using a combination of traditional carpentry and proprietary resin-based solutions such that most of the original

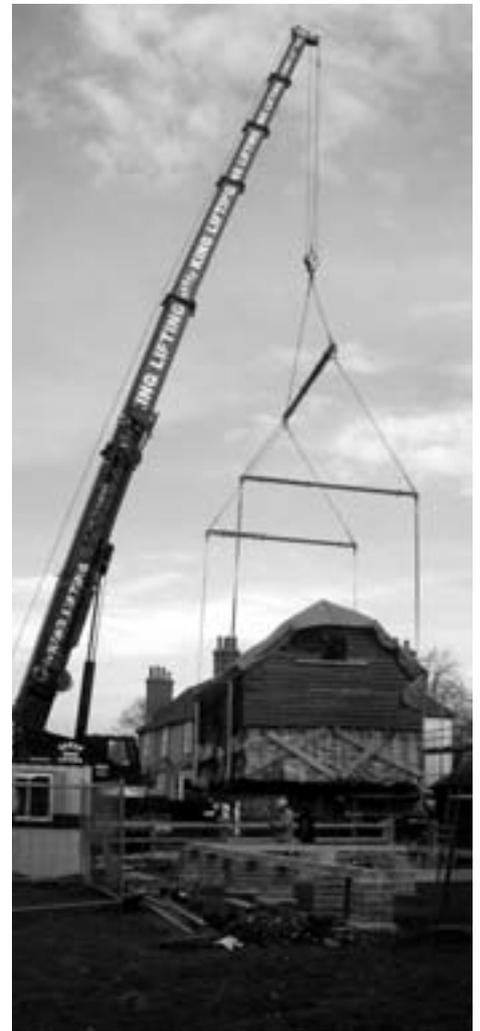
Above left Tensioned wire lighting at first floor.
Above right Granary being carefully lifted onto temporary supports

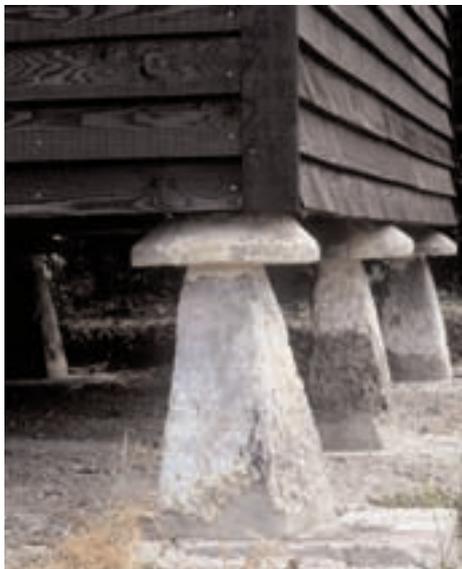
Left Repaired staddle stones - the ground beneath the granary has now been finished with a pea gravel layer
