Location: 112 & 114 Preston Crowmarsh, Nr Wallingford, Oxfordshire
Client: Crowmarsh Battle Farms Ltd

A STABLE WORKING ENVIRONMENT

Redevelopment of redundant stables block to office use and repair of existing Dovecote

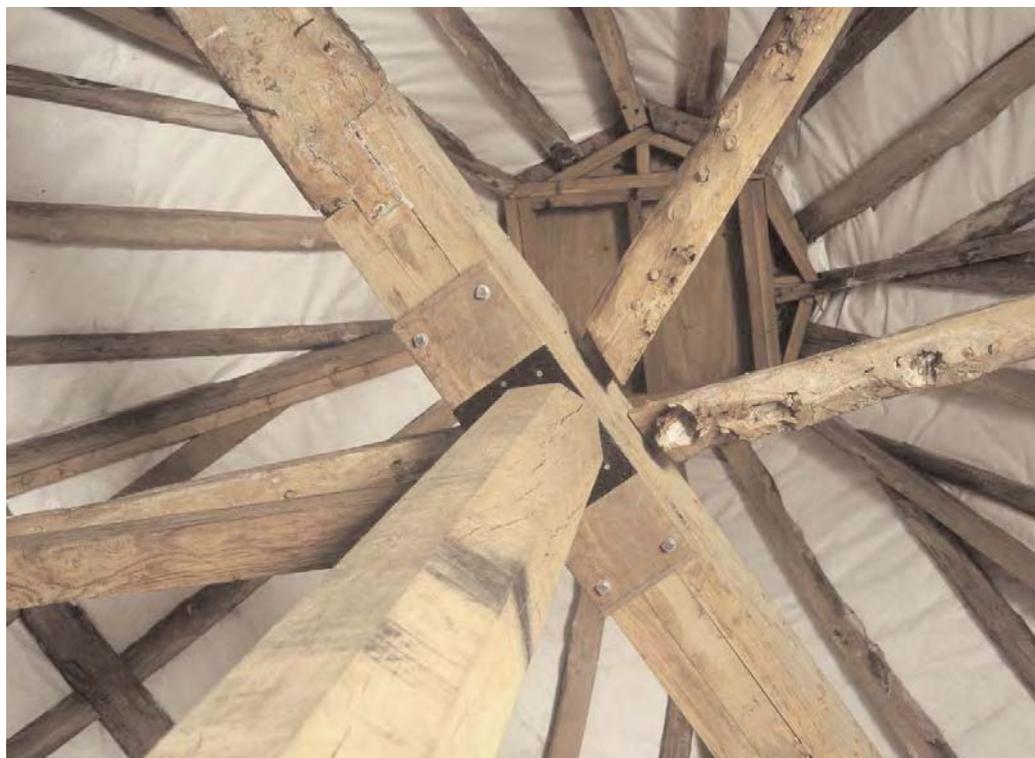
Below Looking up from the central potence column to the roof structure of the dovecote. A white breather membrane (exposed) was used in favour of roofing felt to reflect the light within the roof structure.

The roof was relaid with reclaimed clay plain tiles and bonnet hips over a plain white breathable underlay, especially chosen to highlight the existing timber frame

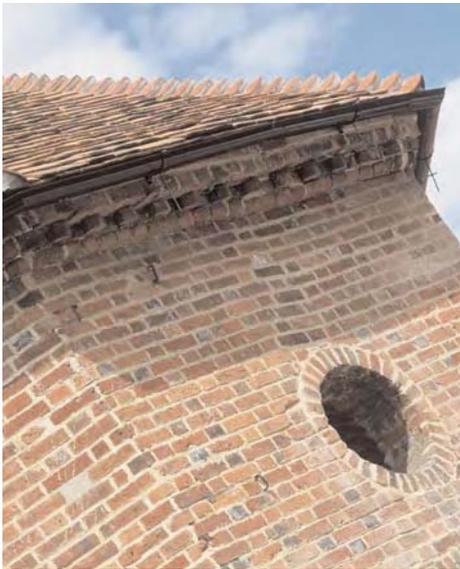
example of its type, but showed signs that subsidence had occurred with large cracks evident at each of the corners and within many of the elevations. More recent repairs in the form of concrete buttresses cast against one elevation were unsightly. Following a programme of complete underpinning of the structure and the subsequent removal of the buttresses, repairs to the brickwork were twofold: initially, bed joints at the corners were chased out at regular intervals, into which steel reinforcement was placed before being repointed. There followed a process of painstaking repair to individual bricks that had cracked, involving sourcing handmade bricks to match the varied course heights around the building and the use of traditional lime mortar.

Below L-R Elevations were repointed following remedial stitching at each corner which had shown signs of spread; Potence ladder rotates within dovecote for the collection of eggs; Dovecote situated in garden behind stables building in foreground.
