TO THE MANOR BARNS

Repair of two listed 16th & 17th century barns and conversion to lettable offices

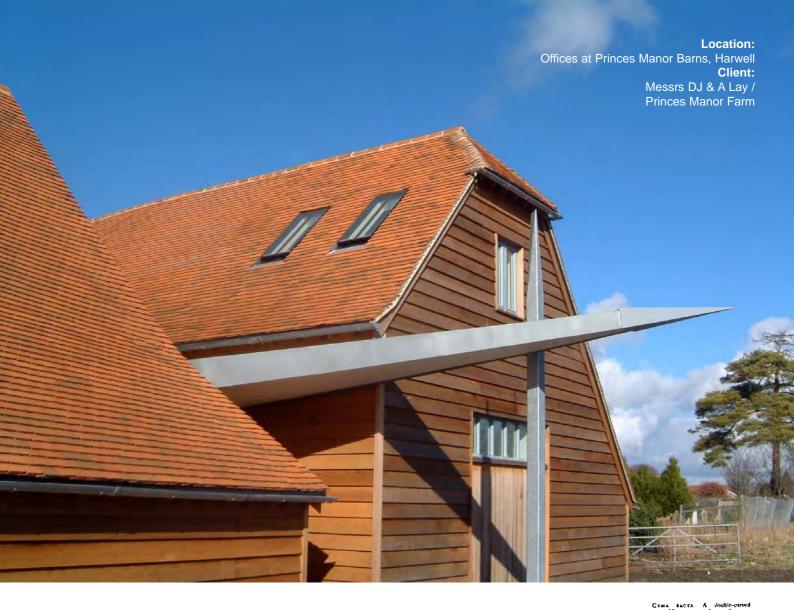
Main picture Original medieval barn, with new mezzanine above trusses beyond.

In addition, new first floor office space has been provided in each barn. In Barn 1, this takes the form of a new mezzanine level on slender columns four metres high accessed via a sleek white spiral stair. Frameless sheets of toughened glass at it's edges allow uninterrupted views across the queen-post trusses within the roof-space.
