Location:
Granary at Crowmarsh Battle Farm
Preston Crowmarsh, Oxfordshire

Client:
Crowmarsh Battle Farms Ltd

HISTORIC STUDY

Repair and refurbishment of derelict granary and conversion to farm office

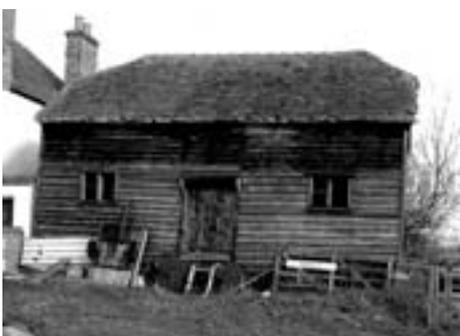
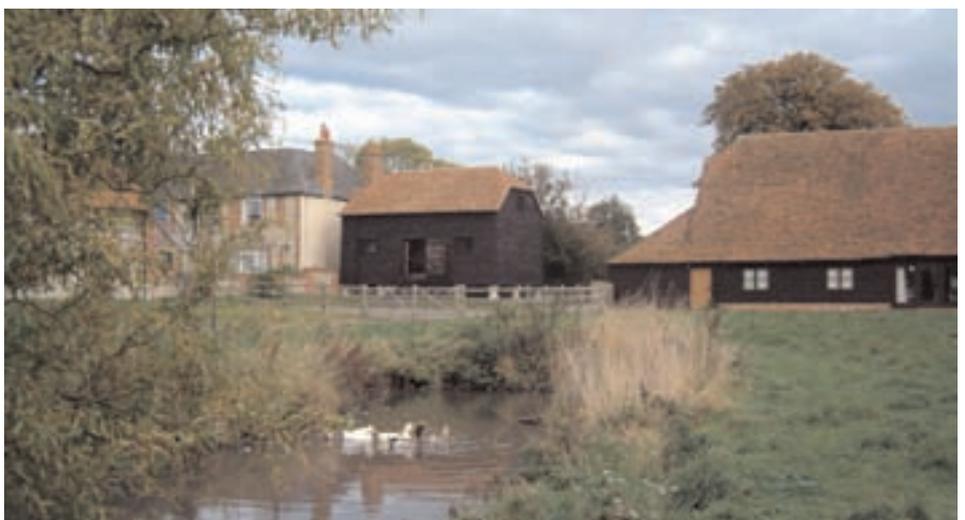
The Grade II listed granary dated 1800 - evidenced by a carved legend on a central post of the existing timber frame - was in a very poor state of repair, with significant subsidence having occurred beneath the fourteen staddle stones on which it stands. The ground subsidence was attributed to the lack of proper footings and any form of

The lower part of the buildings timber frame was in very poor condition too, with the original timbers significantly reduced through rot and insect infestation. Many of the connections had deteriorated completely, which had further contributed to the structure's leaning appearance.

Right The refurbished granary structure, on repaired staddle stones.

Below Granary before refurbishment.

In its new location, the timber frame was repaired using a combination of traditional carpentry and proprietary resin-based solutions such that most of the original

The staddle stones, each comprising a tapered square shaft and separate round 'mushroom' cap to prevent both moisture and vermin ingress to the granary, were re-bedded on the new footings and the granary was once again craned back into its original location for the remainder of the works.

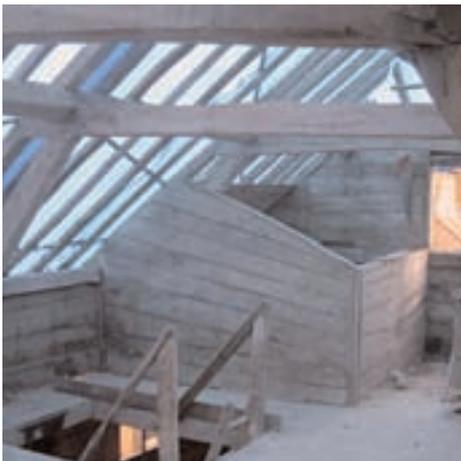
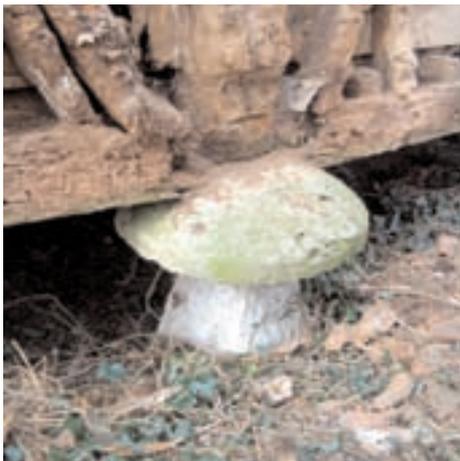
Top First floor, circular wc visible through glass floor panel on left and a series of rectangular holes in the floor boards trace the position of the original grain bins
Above far left Ground floor with modified bin partitions and glass entrance door
Far left First floor during repair. Roof tiles have been stripped off and set aside for reuse over a new layer of internal lining and insulation
Left In many instances, the timber sole plate had completely rotted at the staddle stone locations
Above Roof structure viewed from ground floor: before (L) and after works

Internally, the timber lining boards were marked up before removal so that those in suitable condition could be refitted in their original location. Where necessary, new boards were beaded to match the profile of the originals and all timbers were treated with a preservative before being re-fixed. Many of the grain bin partitions have been retained, while some have been modified to allow access to parts of the building.

Those partitions that have been removed can still be traced in the holes that are left in the first floor boards.

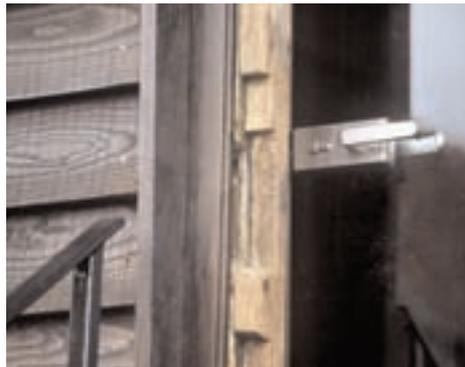
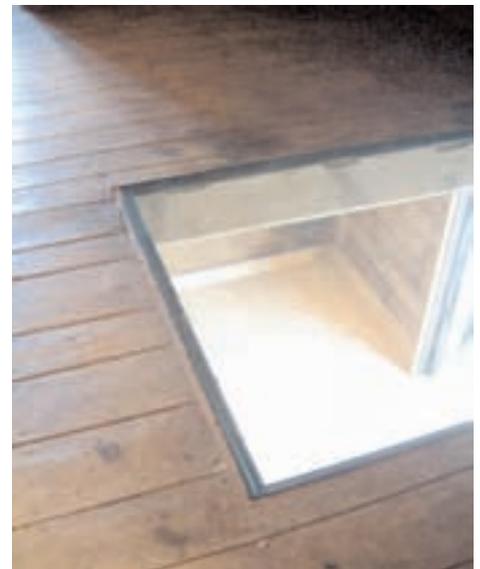
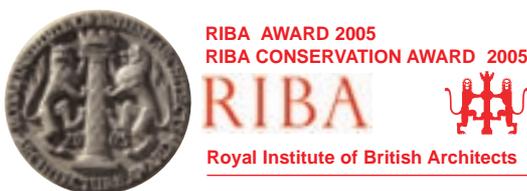
Left Repaired staddle stones - the ground beneath the granary has now been finished with a pea gravel layer

Below Detail of new door set behind the original frame

Right Glass floor panel set into original opening, leaving notched timbers exposed

The original door is thus retained, with the minimum repair required to keep it from falling apart, and in addition a new frameless glass door sits behind the original frame. This door seals and secures the building generally, while the original can still be closed at night to maintain privacy. The glass door allows occupants the ben-

At first floor level a 32mm thick laminated glass panel has been fitted within the now-redundant loft access opening. This has been carefully detailed to ensure that the metal frame is not visible from below. The glass panel maintains a visual connection between the floors and allows one to view the roof structure from ground floor level and so appreciate the overall volume of the building. The panel also allows a good deal
