Location: 112 & 114 Preston Crowmarsh, Nr Wallingford, Oxfordshire
Client: Crowmarsh Battle Farms Ltd

A STABLE WORKING ENVIRONMENT

Redevelopment of redundant stables block to office use and repair of existing Dovecote

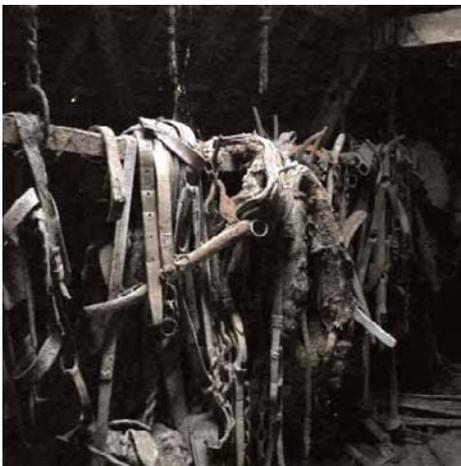
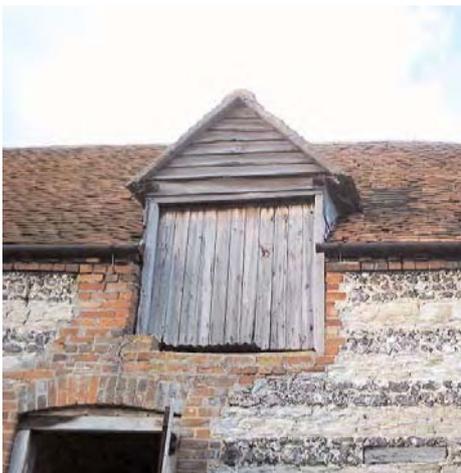
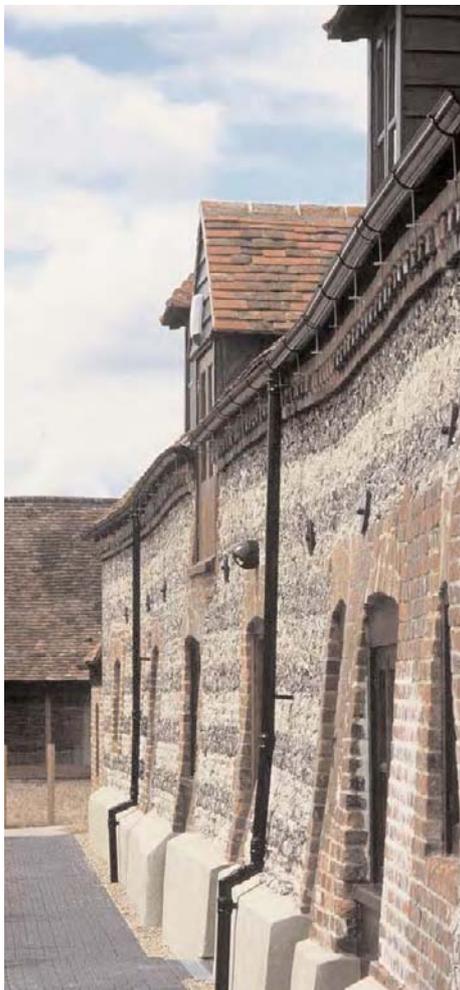
Above left Old tack equipment within loft space prior to works. Lighting provided by one of numerous holes in the roof following high winds.

Far left Single remaining loft access dormer, through which hay would be passed and stored, later to be fed through to stables below.

Centre The external walls were repaired with a selective approach to repointing, so as not to lose the character of the original clunch stone and flint banding. Remedial pattress plates are visible at first floor level.

External walls have been repointed using a traditional lime mortar, however the degree of repointing was limited to only that which was necessary to avoid losing the aged character of the walls.

The timber frame above first floor had also suffered a lot of movement over many years, mainly due to failed dowel connections. Timber frame specialists were involved in the gradual re-straightening of each truss using tensioning straps, before re-pegging the joints in place. The specialists also undertook traditional repairs and modifications to the roof structure after it had been cleaned back and treated for rot and insect infestation. The roof of the building now incorporates two additional dormer windows in the southern roof slope, and the reinstatement of an original hayloft access dormer. To the north, conservation style rooflights have been added and the entire roof has been re-laid using the original clay plain tiles, with the short-fall made up in clay plain tiles to match.

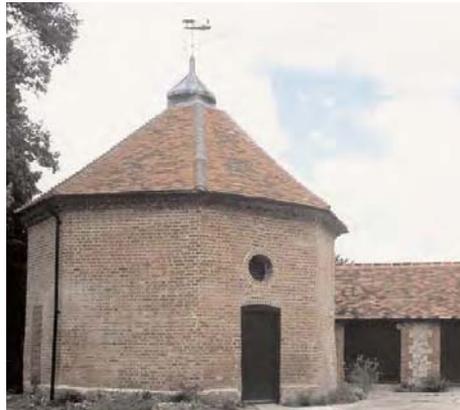
Below Looking up from the central potence column to the roof structure of the dovecote. A white breather membrane (exposed) was used in favour of roofing felt to reflect the light within the roof structure.

The roof was relaid with reclaimed clay plain tiles and bonnet hips over a plain white breathable underlay, especially chosen to highlight the existing timber frame

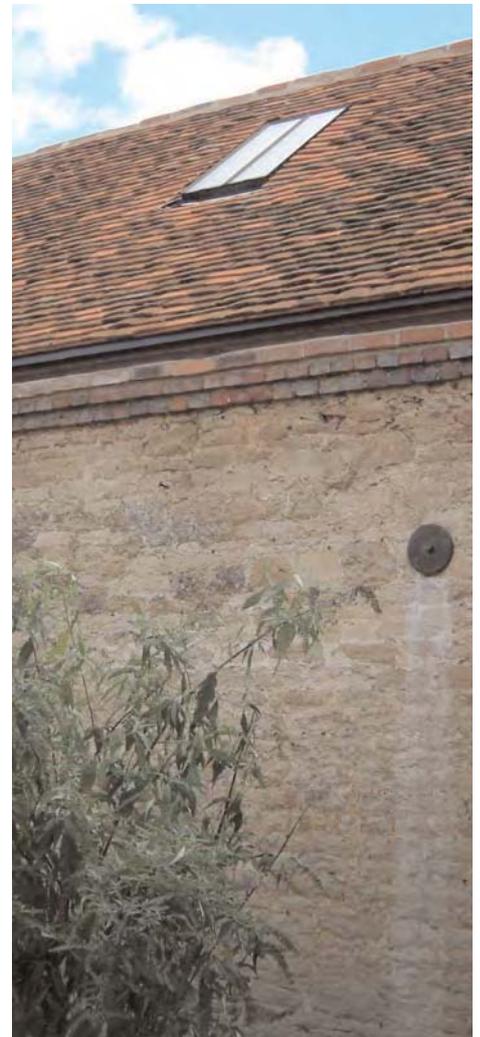
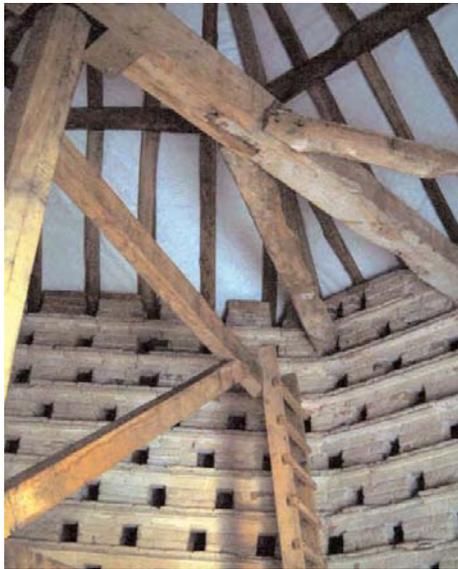
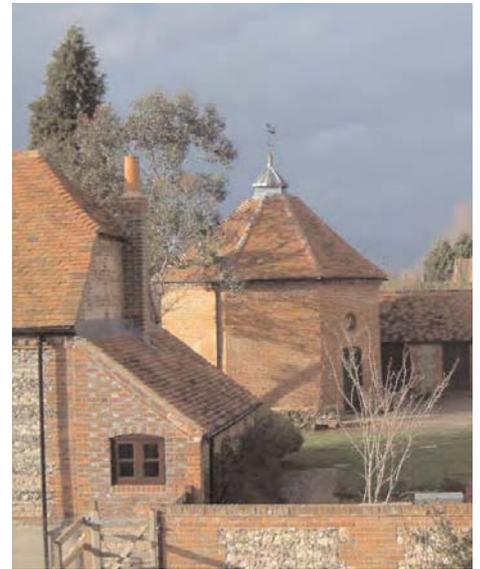
example of its type, but showed signs that subsidence had occurred with large cracks evident at each of the corners and within many of the elevations. More recent repairs in the form of concrete buttresses cast against one elevation were unsightly. Following a programme of complete underpinning of the structure and the subsequent removal of the buttresses, repairs to the brickwork were twofold: initially, bed joints at the corners were chased out at regular intervals, into which steel reinforcement was placed before being repointed. There followed a process of painstaking repair to individual bricks that had cracked, involving sourcing handmade bricks to match the varied course heights around the building and the use of traditional lime mortar.

Below L-R Elevations were repointed following remedial stitching at each corner which had shown signs of spread; Potence ladder rotates within dovecote for the collection of eggs; Dovecote situated in garden behind stables building in foreground.
